Wireless Sensor for Monitoring Acoustic Induced Vibration

Abstract—Acoustic induced vibration can cause museum art objects to deteriorate at a very rapid pace, thereby endangering the cultural heritage they conserve. Here, wireless triaxial MEMS accelerometer nodes were used to monitor the effect of loud and live music played during social events at the Walters Art Museum on mock art objects. During the social event, continuous wireless vibration activity monitoring was performed from sensors placed on respective blocks with the art object under test to provide real-time vibration activity information. The vibration induced by the music, as well as the vibration propagation through the specific object via the mounting or display mechanism were evaluated. The loud music played generated high acoustic energy that excited the object vibration modes and placed the object at risk of induce fatigue cracking and “walking”, all of which can potentially cause catastrophic damage in extreme cases. The acoustic field with an intensity of 90 dB induced the highest level of vibration. The display block orientations were observed to contribute to the vibration activity, wherein, the vertical or

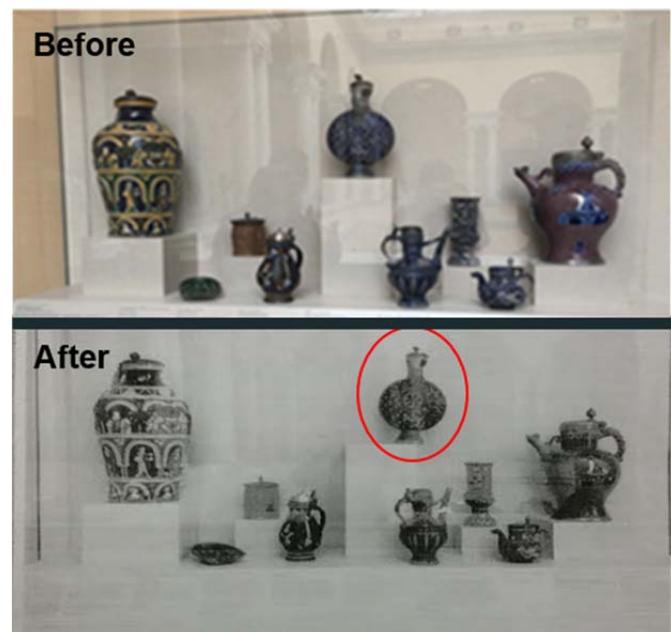
Fig. 1. Art objects in the Walters Art Museum show evidence of “walking” across their displays. Prolonged and repeated exposure to vibrations from music events is considered to be the cause.

artifacts to move across their display blocks. When “walking” occurs, artifacts are at risk of toppling over and damaging themselves and the surrounding artifacts.

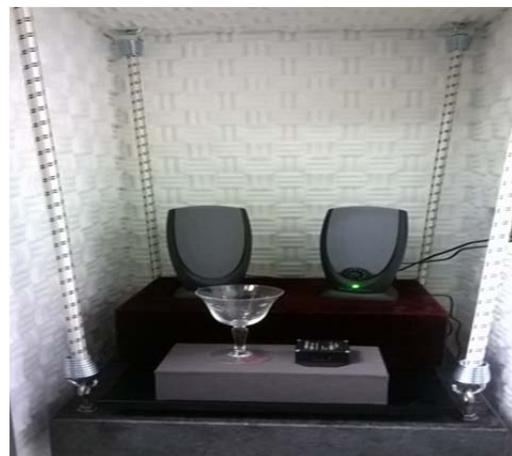
Fig. 3. Experimental set-up using a vibration isolation chamber.

With this wireless accelerometer sensing system, it is possible to access the vibration activity information of the monitoring nodes via an internet-connected device running Node Commander® software. Initial sound intensity experiments were performed in a vibration isolation chamber as shown in Fig. 3 to measure the vibration induced by the music without the interference of external sound. The layers of padding and suspended platform employed in the chamber further dampen any external vibration coming from outside the chamber. Studies were conducted at various sound intensities. The accelerometer sensors were used to monitor art objects placed on pedestals and display blocks in such a way that they provided an indication of the local responses.

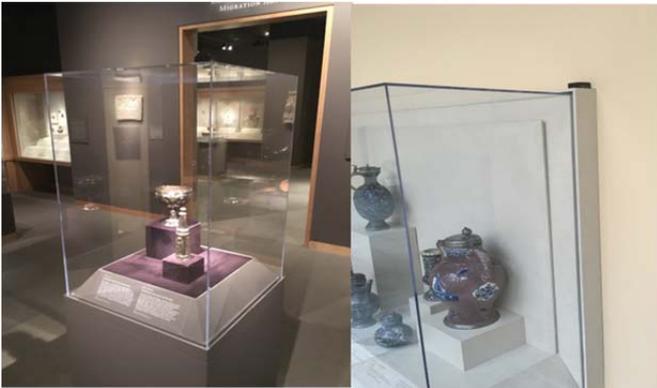
Fig. 7. Vibration induced at (A) 440 Hz (80 dB) and (B) 48.1 Hz (90 dB) when display case is freestanding or mounted to wall. A composite plot is depicted to compare the normalized acceleration. [Freestanding: Red and Mount to Wall: Blue].

In museum settings, display cases are commonly left freestanding or mounted to a wall as shown in Fig. 7. To gain a better understanding as to whether the wall intensifies or dampens the vibration induced in the art object being displayed, the initial test focused on a freestanding display case placed 16 feet in front of the speakers. The goblet was then placed in the center of the display platform and the accelerometer node was placed on the back corner of the platform, all of which were enclosed with the Plexiglas cover and interrogated at 440 Hz (80 dB) and 48.1 Hz (90 dB). The interrogation was repeated with the display case firmly mounted to the wall. At a frequency of 440 Hz, the wall appeared to have a slight impact on the vibration induced in the art object. This represents the mechanical vibration in the display case being amplified relative to the original source excitation (the wall). Thereby, we observe more induced vibration on the object as shown in Fig. 8. This increase in vibration may be due to the inertial forces of the object.
